**THE CATHOLIC DIOCESE OF ARLINGTON**  
**St John Bosco**  
**315 N. Main Street**  
**Woodstock, VA 22664**

**OFFICE OF RISK MANAGEMENT LOSS CONTROL SURVEY**  
**May 15, 2014**

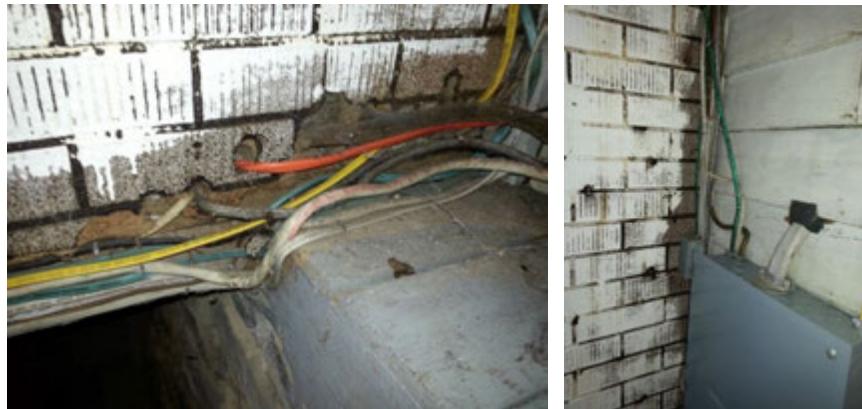
- 14-05-01     \***Electrical - Unknown.** The St. Dominic House electrical system has undergone many changes and additions over the years (similar to the other buildings). The current conditions of these changes should be evaluated by a certified competent electrician. The evaluation of electrical condition should be campus wide. Electrical panels should be evaluated and circuits marked appropriately.

*Images of unknown electrical condition*

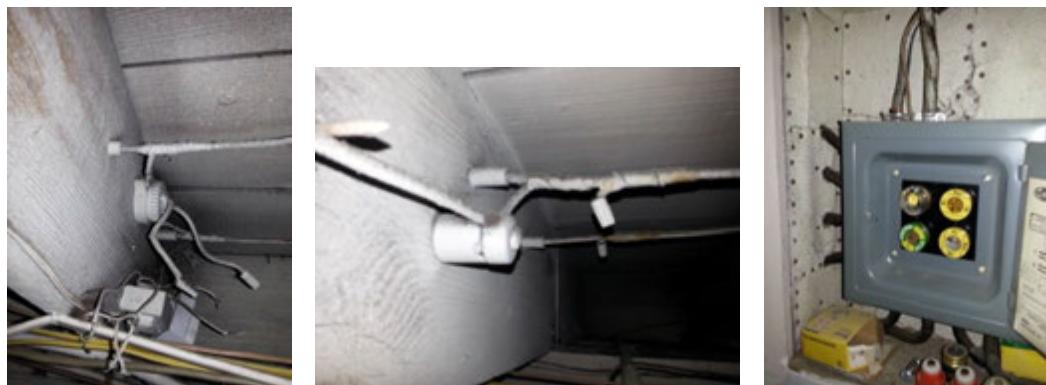
- 14-05-02     \***Electrical - Outdated.** Test equipment confirmed power in outdated knob and tube wiring. This wiring is 50 -100 years old. Even properly maintained and not overloaded, the wiring insulation deteriorates over time. The potential of overloading with modern electric demands and materials deteriorating over time, increase the risk of fire. There is additional risk if the "conversion" to conventional wire was done incorrectly. Knob and tube wire should not be used or tied in to at any point. A survey of solutions should be conducted by a competent certified electrician.

*Images of knob and tube wiring still in service and other outdated wiring*

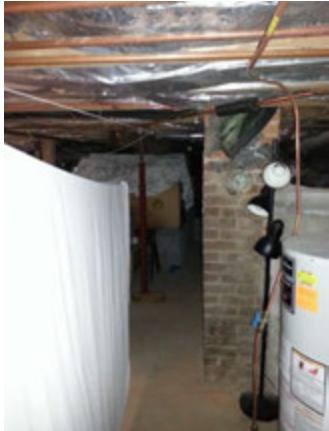
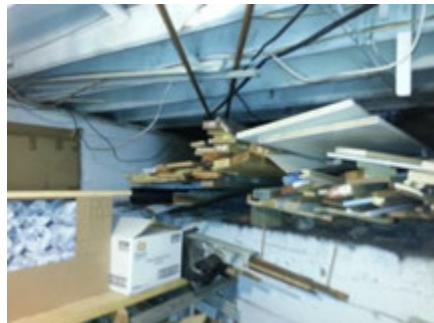
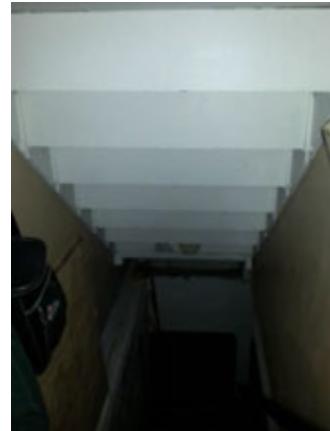
- 14-05-03 \***Fire - Combustibles**. Throughout the campus, there are mechanical rooms and combustibles under occupied space. The majority of these areas have exposed structural and other building components. These unprotected building components will allow fire to spread more quickly. It also contributes to earlier failure of the floor above, limiting egress and adding hazards for the emergency responders. A method to slow the spread of fire should be considered.

*Images of expose ceiling floor from mechanical/electrical rooms*

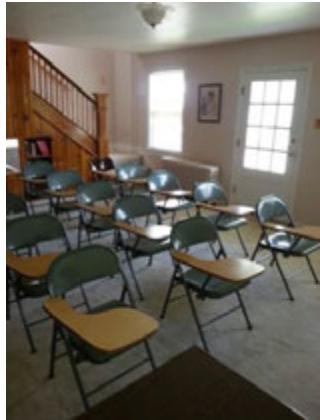
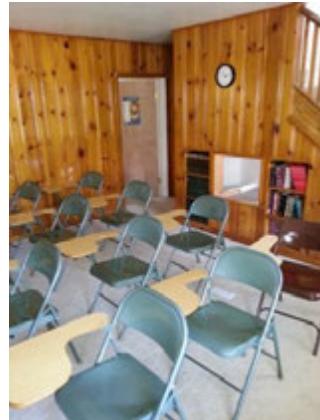
- 14-05-05 \***Fire - Combustibles**. The St. Dominic House main level classroom has combustible wall coverings on two walls. The walls leading upstairs are also covered in wood. These conditions will speed the spread of fire. Flammable curtains should be removed from the closet and passage doorways.

*Images of combustible wood wall coverings in classroom and stairway*

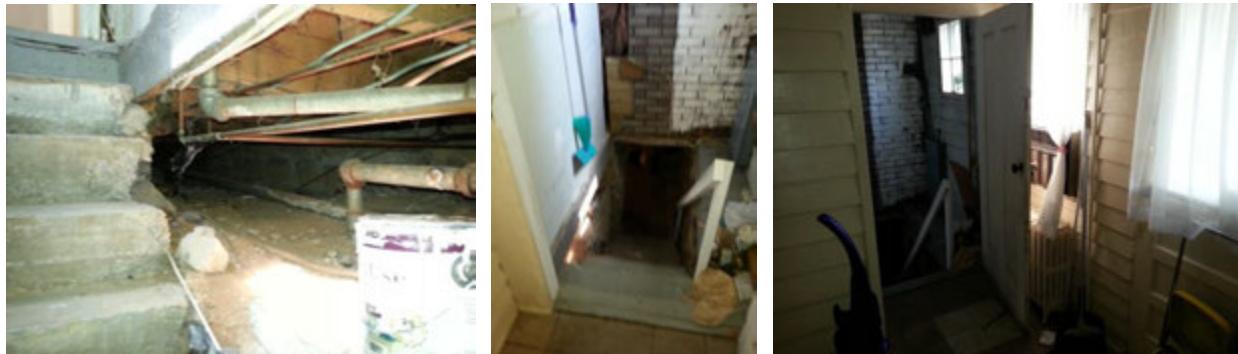
- 14-05-06 \***Fire - Breech**. A fire rated barrier, needs to be between the mechanical/electrical room (basement) and the floor above which is the classroom. This will also lead to the quick spread of fire to the classroom and the rest of the building.

- 14-05-07      **Safety - Steps.** The steps leading to the basement are narrow and steep. Safeguards should be in place to limit access. Caution signs to remind user to watch their step should be posted in visible locations.

*Images of open fire breech and basement entrance*

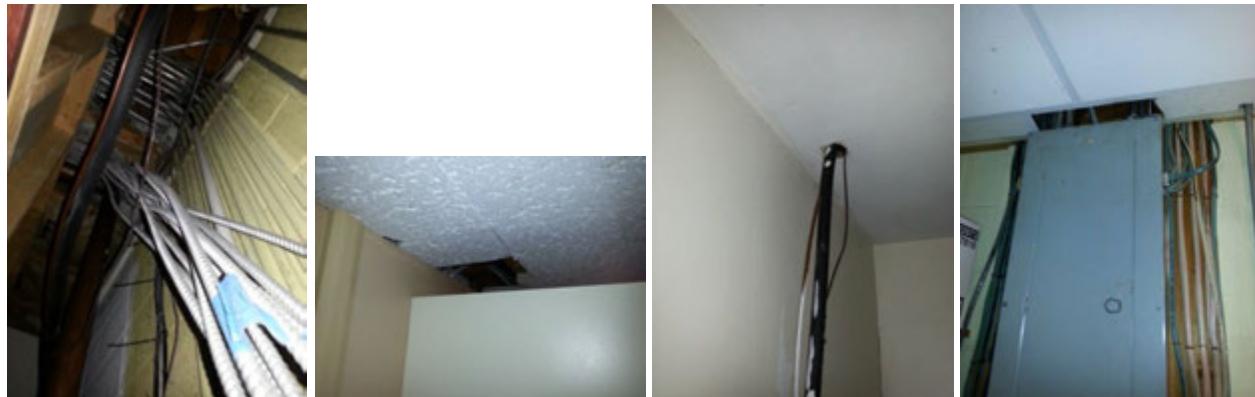
- 14-05-01      **Fire – Breech.** Smoke and fire will travel through openings in the walls and ceilings. Ceilings and walls should not have holes or unprotected openings. This may also reduce heating and cooling efficiencies. Repair holes in walls and ceilings throughout the campus. These could be filled with fire rated caulk, sheetrock or other non-combustible material. Replace ceiling tiles where they have been removed.

*Images of wall/ceiling breech*

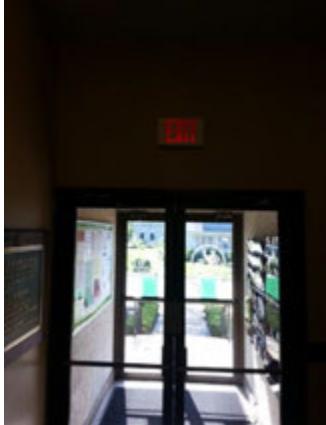
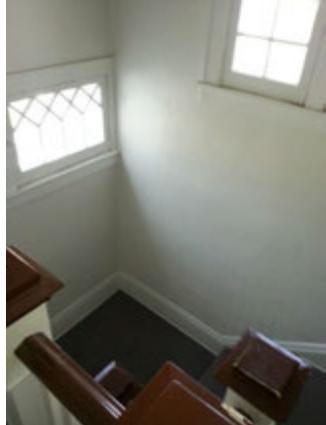
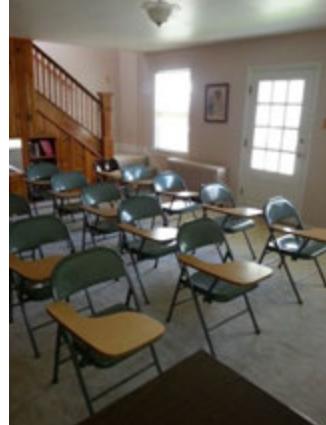
- 14-05-03     **Fire – Emergency Lighting.** Stairs, exits and hallways should contain adequate lighting to assist with evacuation during a power outage after dark.

*Images of some of the areas needing lighting*

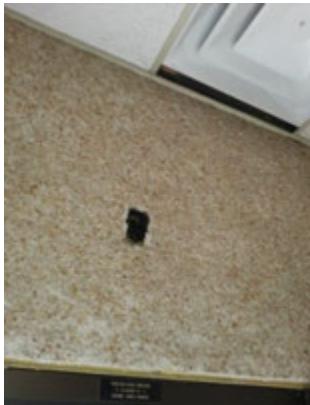
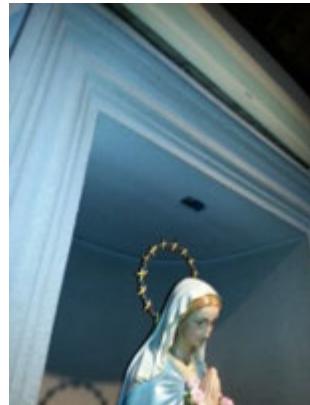
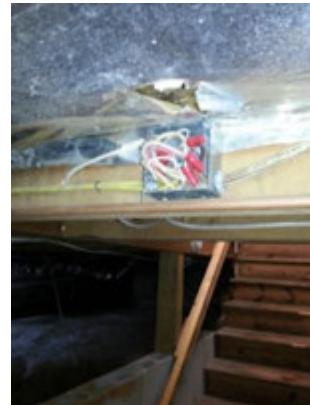
- 14-05-04     **Electrical – Cover Plate.** Cover plates are missing on electrical boxes. Insure wiring is capped and appropriate plates are on all junction and other electrical boxes.

*Images of open junction boxes*

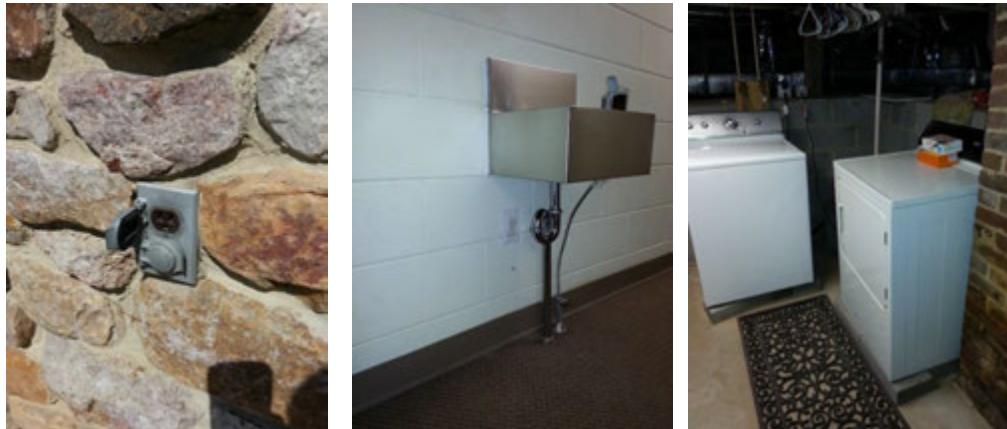
- 14-03-06 **Electrical – GFCI.** Ground Fault Circuit Interrupters (GFCI) are required to be installed within six feet of wet locations and when exposed to weather. Include sinks outdoor outlets and other wet locations. This can be accomplished either at the electric panel, or more easily with a GFCI outlet. Insure all wet locations on the campus have the correct outlets to minimize the risk of electrical shock injuries.

*Images of some area requiring GFCI*

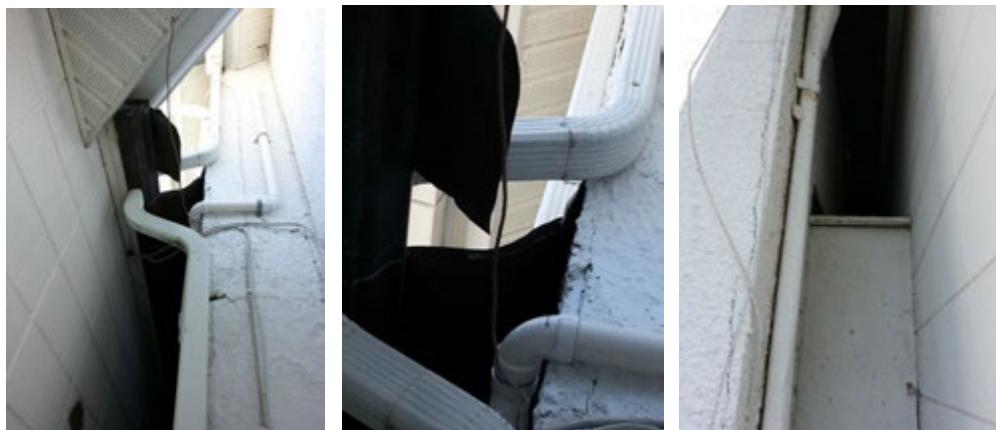
- 14-05-08 \***Maintenance – Exterior Finishes.** The passage between the church and office building does not conform to construction best practices. It is a painted plywood structure with 2x4 floor joists. Although there are no issues evident at the time of the inspection, it will require periodic monitoring to remain serviceable. The water is kept off of this area by metal flashing connected on one wall diverting rain to the gutter of the other building. The area also presents areas for nesting of insects and rodents that may find their way into the building.

*Images of two buildings connecting*

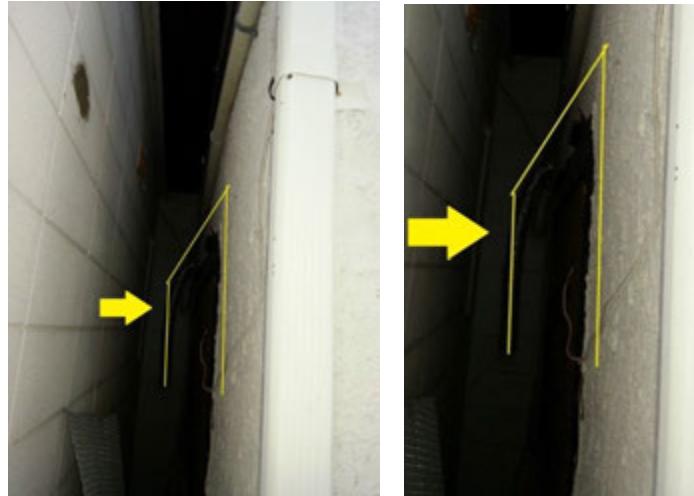
- 14-05-10     Safety – Exterior Finishes. Not obvious at the time of inspection, review of a photo shows evidence of a large hole in the exterior with unknown covering to the interior.

*Images of hole in wall*

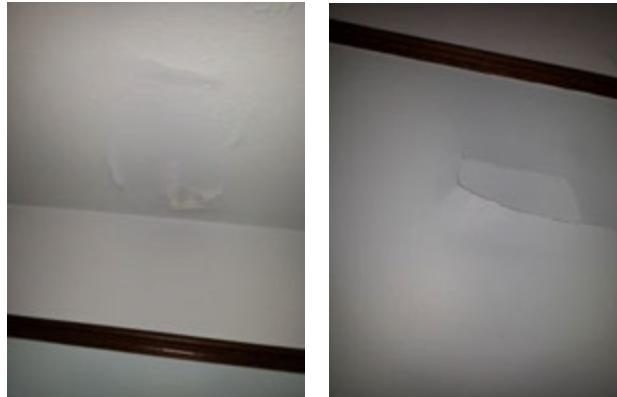
- 14-05-11     Maintenance - Paint. The paint in the priest's residence is peeling and cracking. It is not clear if this is normal wear or signs of moisture issues. Inspect the cause and address if required before repainting.

*Images of paint cracking*

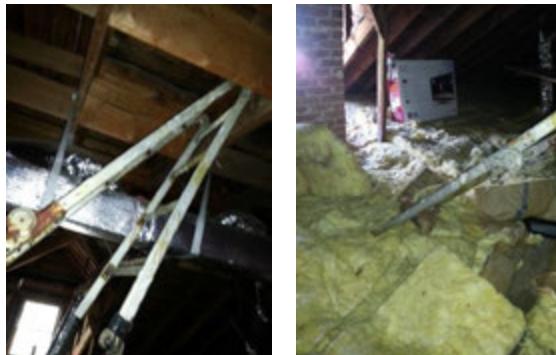
- 14-05-13     Safety – Ladder. The ladder in the attic is placed over the insulation on the floor and is not at a proper working angle. Ladders should not be stored in a “climbable” position. Remove and store properly if not being used. Inspect ladders prior to each use. They should be rated properly for the intended use and user.

*Images of ladder stored improperly*

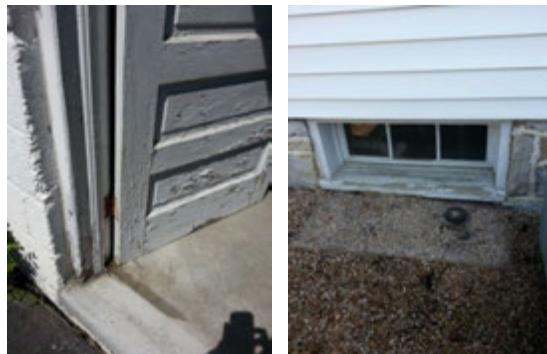
14-05-16 **Maintenance - Paint.** Doors, windows, sills and other exterior surface have peeling paint and exposed wood. These areas need to be protected from the weather to prevent deterioration and rot. Survey all exterior building surfaces and paint, seal or protect appropriately. Siding, soffit and fascia should also be inspected.

*Images of paint peeling*

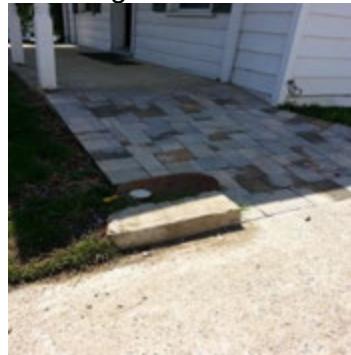
14-05-21 **Safety – Trip/Fall.** The walkway to the front of St. Dominic House has a raised water meter and concrete block presenting a trip and fall hazard. Place a warning sign to alert or a barrier to redirect pedestrians around the hazard. Insure proper lighting for safe access and egress from the building.

*Images of trip hazard*

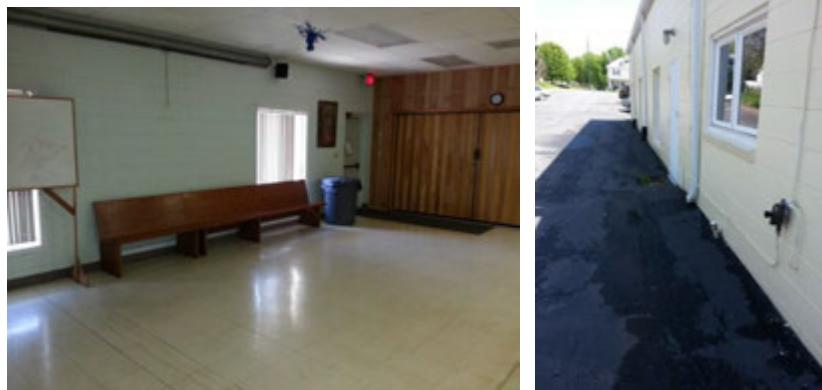
14-05-24 **Fire - Egress.** Two of the Hanley Hall doors exit to the parking lot side of the building. These doors and the drive areas should be marked to deter blocking the full swing of the doors.

*Images of exit from Hanley Hall*

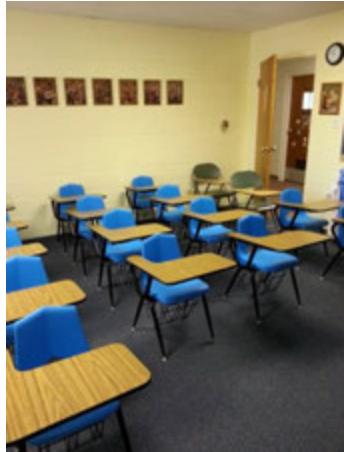
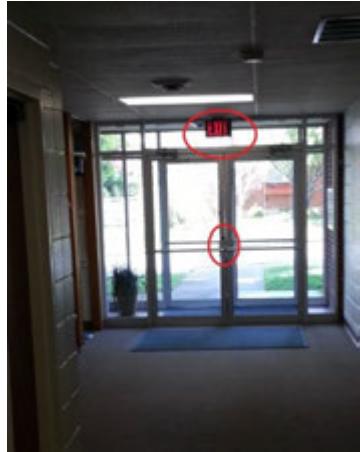
14-05-25 **Fire - Egress.** Classroom doors should have full range of motion. Even though there is another exit from the room. Classroom size and arrangement should be monitored to insure timely exit is always possible. The doors currently need a key to exit. A policy must be in place to have doors unlocked anytime the building is occupied, until the doors can be equipped with push activated panic hardware.

*Images of egress issues*

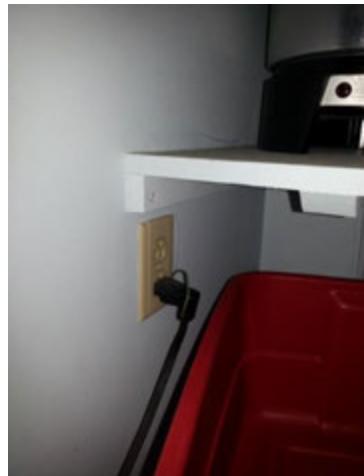
14-05-28 **Electrical – Refrigerator.** In the old church the kitchen refrigerator has a plug adapter to reduce from three to two prongs. It is plugged into a three prong outlet. Rotate the outlet to accept the cord appropriately. The fridge also has been leaking and forming ice outside on the back. Repair or replace. The hall has three refrigerator/freezers plugged in and running. Consider consolidating items if all are not needed to reduce energy consumption.

*Image of improper wiring*

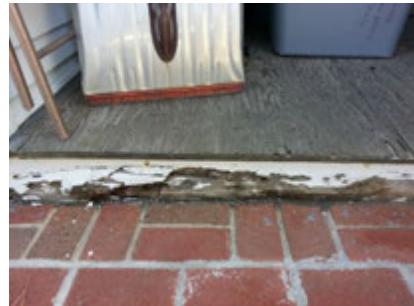
14-05-30      **Maintenance – Water Damage/Wood Rot.** The threshold to the porch of the outreach building is rotted. The porch floor is untreated and will continue to deteriorate. Assess all exterior finishes to insure adequate protection from the weather.

*Image of evidence of water damage and un painted exterior*

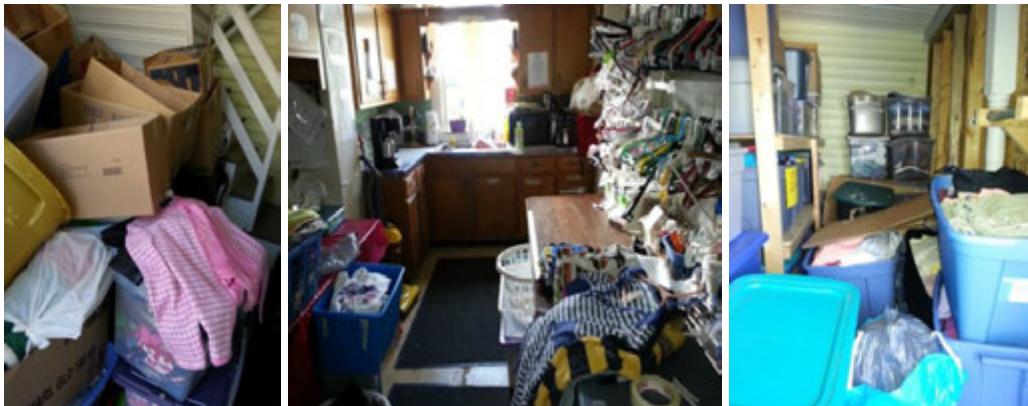
14-05-31      **Safety - Storage.** The building content has reached capacity. Although organized and displayed well, many areas of the outreach building seem to be cluttered. This increases not only to the risk of injury, but egress and fire issues also. Storage should be neat and orderly with clear aisle ways leading to the exits. The building is afforded much natural lighting and only occupied during daylight hours. If the hours should change, emergency lighting should be added.

*Images of storage issues*

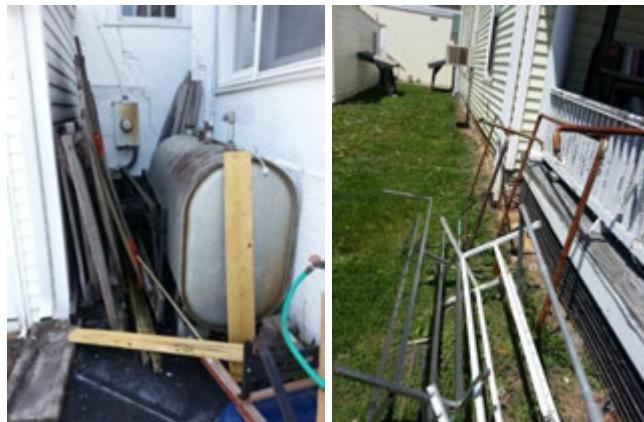
- 14-05-32 **Maintenance – Outside storage.** There are a number of areas with outside storage that present hazards. Long term storage next to buildings encourages nesting of rodents and insects. Storage of excess items not needed presents injury hazards. Store items neatly and appropriately. Eliminate items no longer needed.

*Images of storage issues*
