**THE CATHOLIC DIOCESE OF ARLINGTON**  
**Saint John Bosco Catholic Church**

**OFFICE OF RISK MANAGEMENT**  
**Playground Safety Inspection**  
**May 8, 2017**

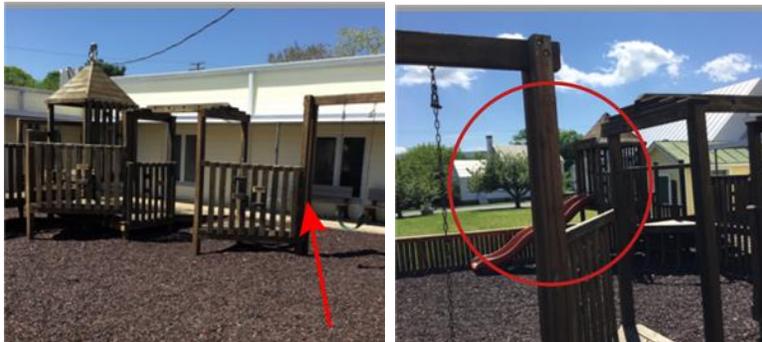
**17-04-01** Support/Structure - Post. The stability of at least one side of the swing support post is weak. Remove or replace weak posts. Replace the lag bolts with approved continuous fasteners that are long enough to fasten both posts and the center beam.

*Images of unstable support beam*

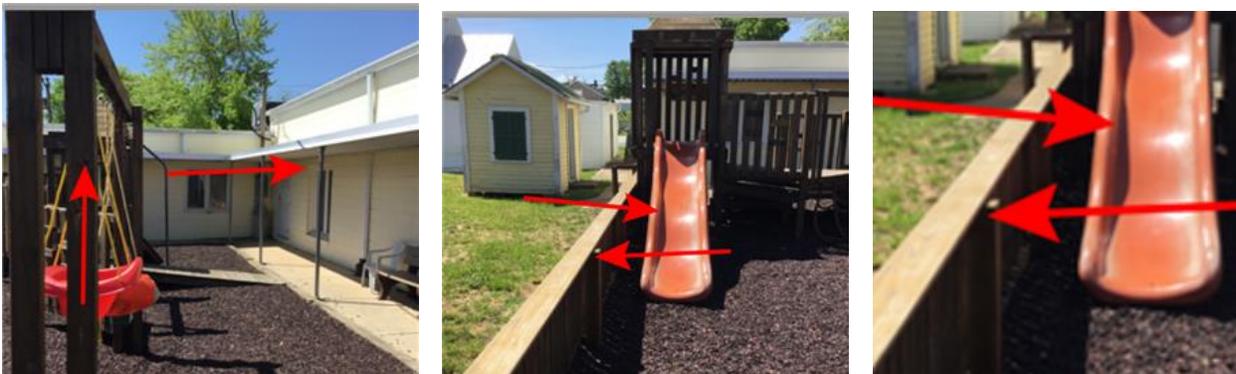
**17-04-02** Use Zone - Inadequate. The swing for older children was removed immediately because of the weak post and lack of adequate use zone (i.e., the 8-foot high beam on the swings requires 16 feet of front and back clearance). Remove the swing beam or use only for infant swings. The slide is also an issue. Since the fence is within the safe use zone of the slide (see pictures), either the fence must be moved or the slide removed.

*Images of improper use zone*

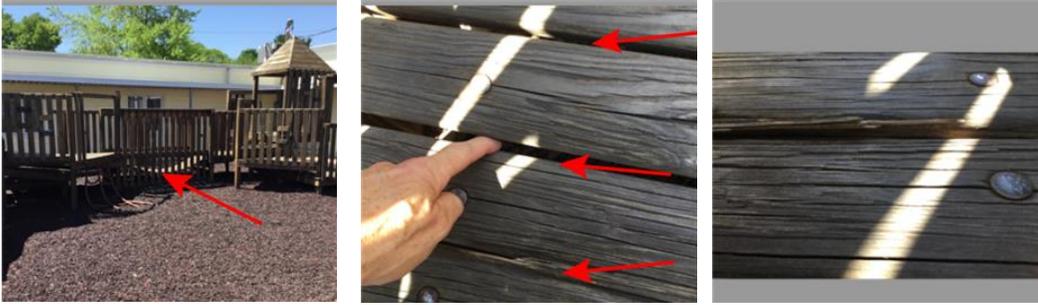
17-04-03

Crush/Shear - Bridge. The bridge slat spacing allows for potential pinching or crushing injuries. Use spacers to prevent slats from causing a crush injury or tighten slats to prevent access to pinch points.

*Images of loose crush and pinch hazard*

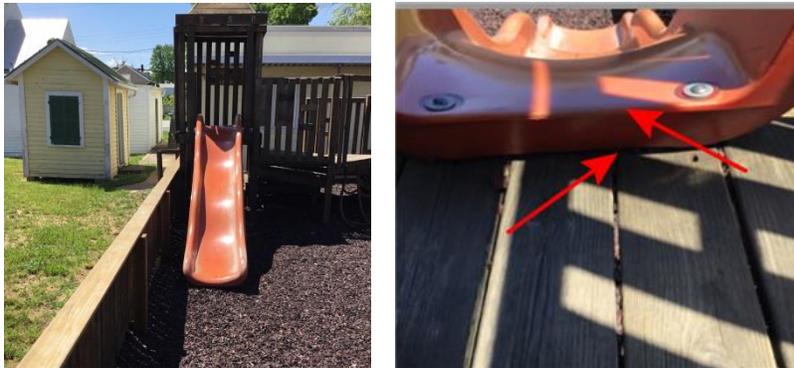
17-04-04

Slide – Transition. The entry to the slide should be designed to guide children to a seated position. The slide bed way should be flush with the platform to minimize trip potential.

*Images of trip transition*

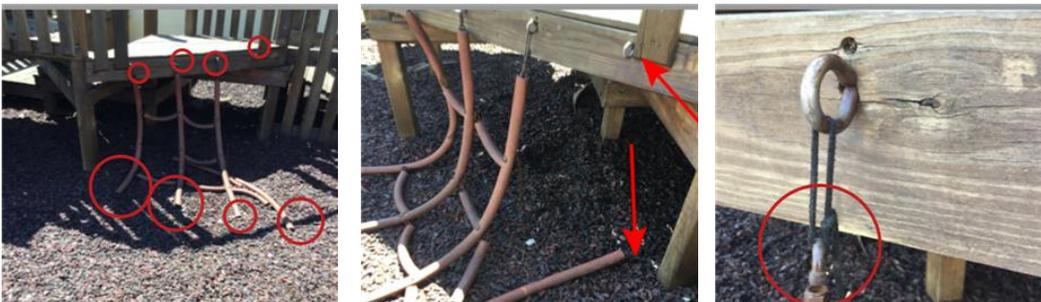
17-04-05

Attachment – Anchor Points. The chain climber has multiple attachment points that are not connected. One is connected with only a string. Remove climber or attach all attachment points properly.

*Images of improper anchor attachments*

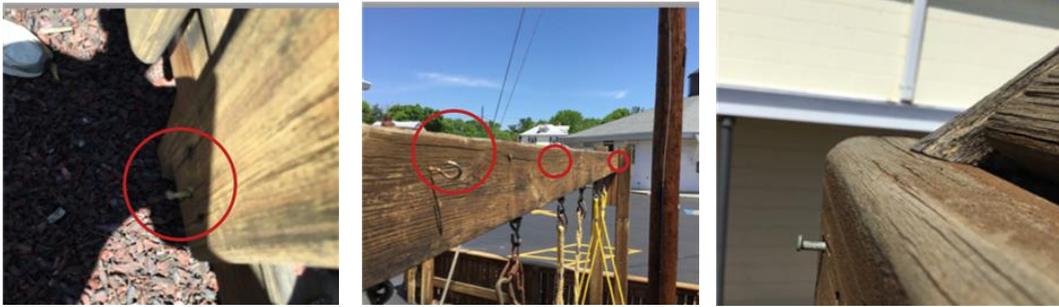
**17-04-06** Protrusion - Fasteners. Many fasteners have come loose and are protruding from the playground equipment. Secure all fasteners to be flush with the surface.

*Images of loose fasteners and protrusions*

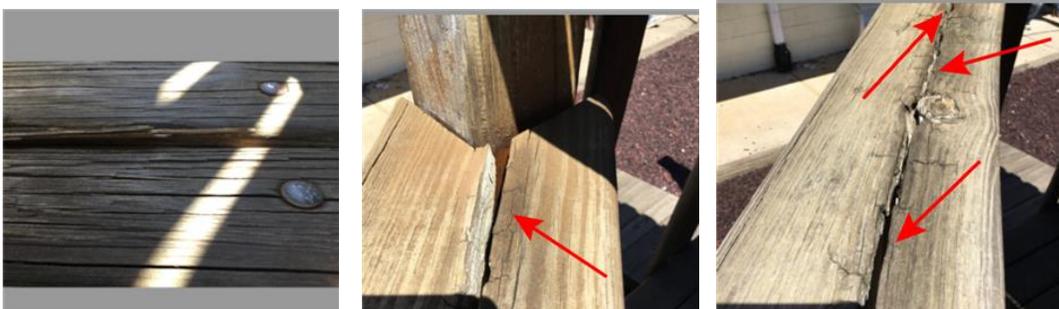
**17-04-07** Surface - Splintered. Rails, platforms, posts and barriers are cracked and splintered. Repair finish to a smooth continuous condition.

*Images of loose fasteners and protrusions*
