**THE CATHOLIC DIOCESE OF ARLINGTON  
Saint John Bosco Catholic Church**

**OFFICE OF RISK MANAGEMENT LOSS CONTROL SURVEY  
Report created May 7, 2017**

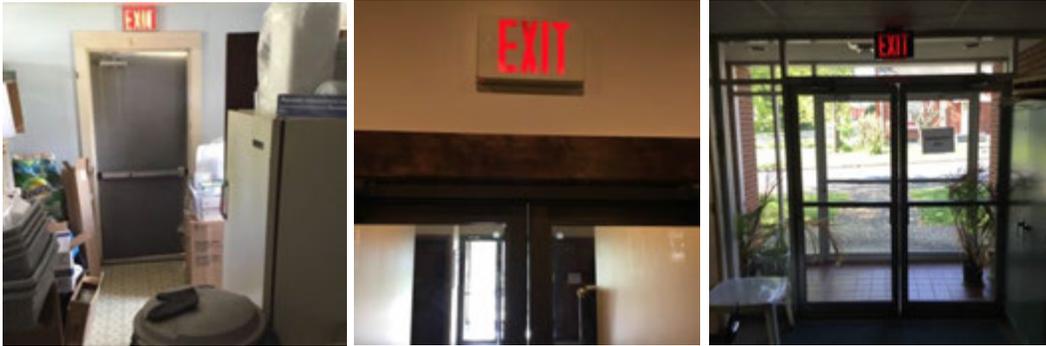
*Images of exit lights*

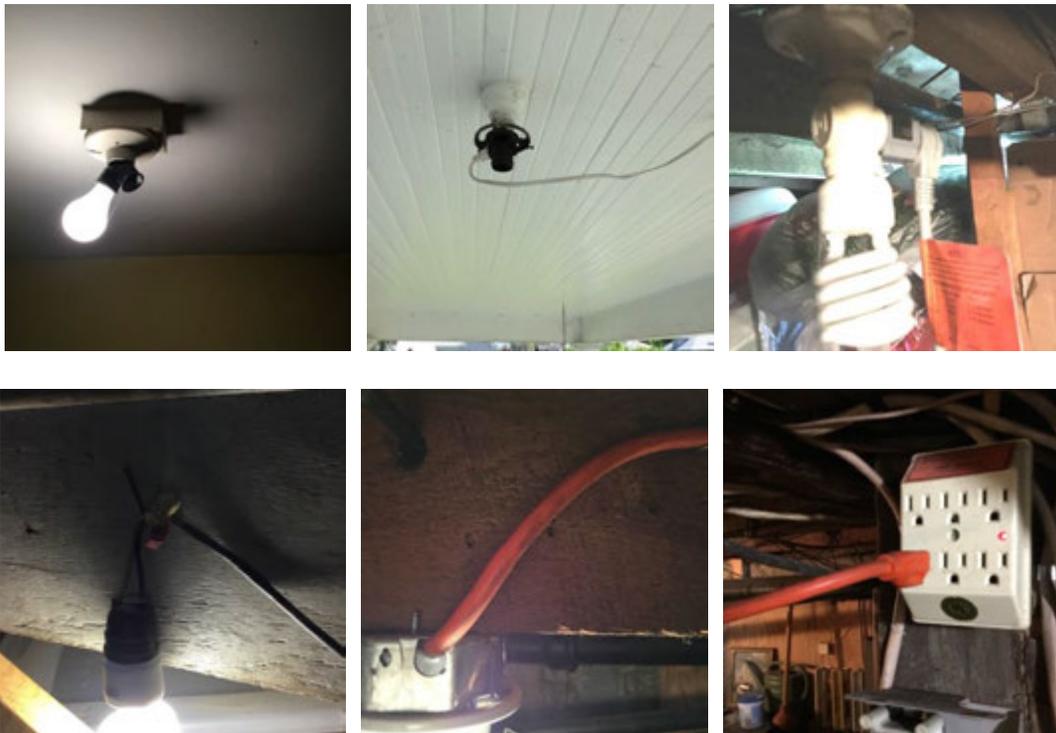
**17-04-02**

Electrical – Improper Wiring. Several hazards were discovered with the electrical wiring. Lighting circuits are not intended for use as outlets. A large dehumidifier is powered from an under powered lighting circuit with an adapter being used to eliminate the grounded safety. Remove the outlet adapters from the light bulb sockets. In one case a cord plugged into an outlet is being used to power a junction box with permanent wiring supplying power to outlets and lights. Supply power to fixtures and appliances in an approved manner.

*Images of improper electrical*

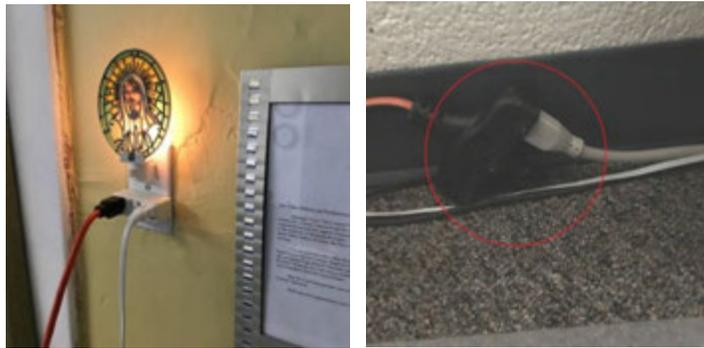
**17-04-03**

Electrical – Outlets. Multi-plug adapters should be avoided when possible. If required the adapters must provide circuit breaker and surge protection. Remove or replace the adapters as needed. As with all outlets, cords, and power strips, care should be taken to not overload the designed amperage of the circuit breaker.

*Images of multi plug adapters*

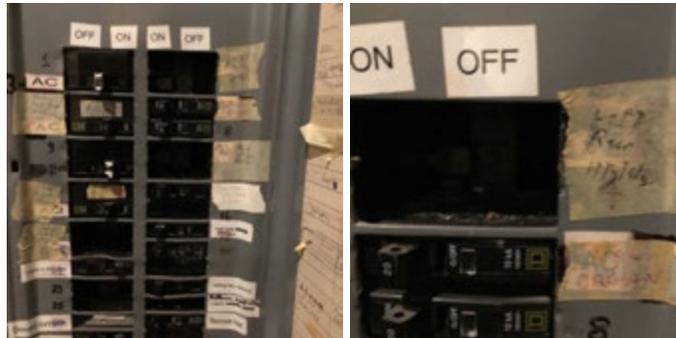
17-04-04

Electrical – Open Breakers. The breaker panel has areas with unprotected access to the wiring. Place acceptable blank covers in the panel to restrict access to the energized wires.

*Images of open breaker spaces*

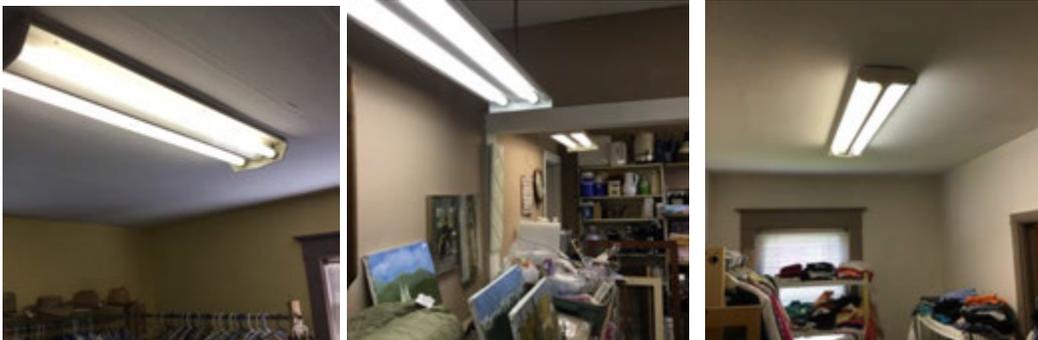
17-04-05

Electrical – Exposed Bulbs. Take steps to ensure all bulbs and/or fluorescent lamps are protected from accidental contact or breakage by a suitable fixture or guard. Plastic sleeves are acceptable for fluorescent lamps.

*Image of lights without covers*

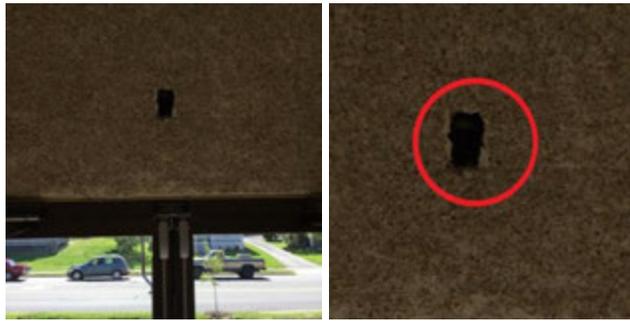
17-04-06

Electrical – Cover Plate. Junction boxes need proper covers. Follow up behind contractors to insure proper workmanship and completion of job. Install appropriate covers or fixtures as needed. The opening above the main exit/entrance may be an ideal location for a combination exit/emergency light (depending on the power source).

*Images of open electrical*

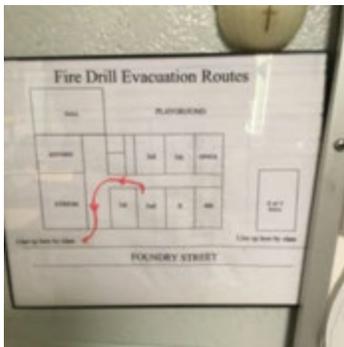
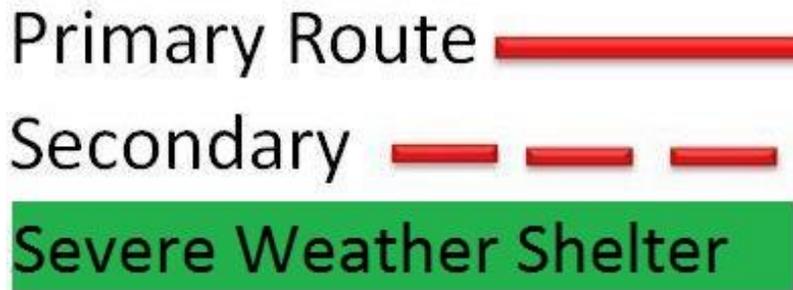
**17-04-07**

Egress – Exit Map. An evacuation route should be posted in each classroom and meeting room. Maps should include the primary, secondary routes along with severe weather shelter areas. Update classroom maps using the symbols below to assist in standardizing throughout the diocese.

*Images of evacuation map and standard recommendations*

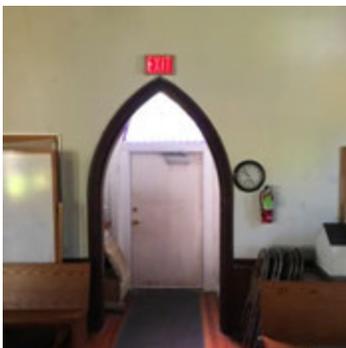
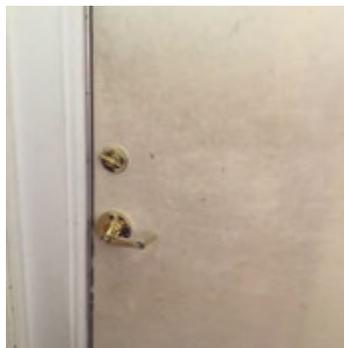
**17-04-08**

Fire – Egress Deadbolt. Doors used as emergency exits may not be locked with a device requiring a second motion while the building is occupied. Do not latch deadbolts during occupied hours. Remove the secondary lock or use signage to remind staff and volunteers to keep doors unlocked.

*Images of exit*

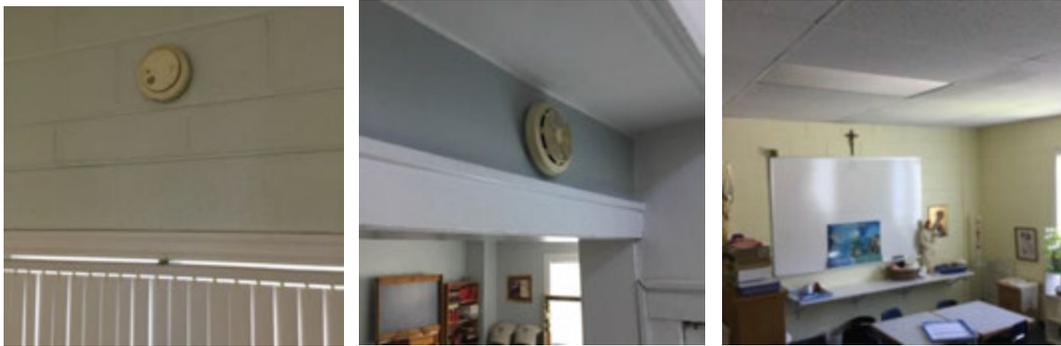
**17-04-09**

Fire – Smoke Detector. Early detection of smoke and fire saves lives. Change batteries at least annually. Replace smoke detectors after ten years of use. Regularly inspect smoke detectors for proper operation. Encourage staff and residents to report smoke detectors that are not working or not working properly. Do not disable or remove smoke detectors.

*Images of outdated and missing smoke detectors*

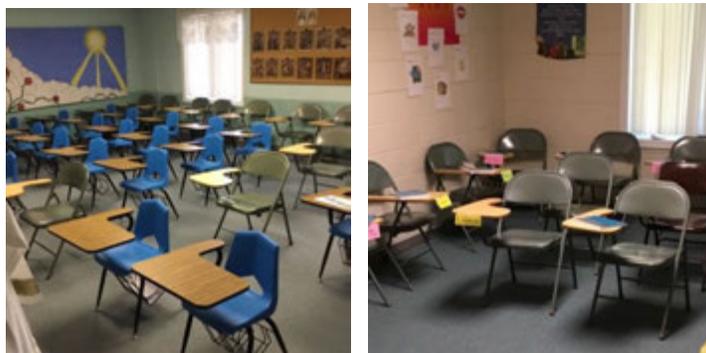
**17-04-10**

Fire – Occupancy. The occupancy in the classrooms reached capacity during religious education classes. Make plans to keep class sizes within the maximum occupancy levels.

*Images of classroom areas at capacity*

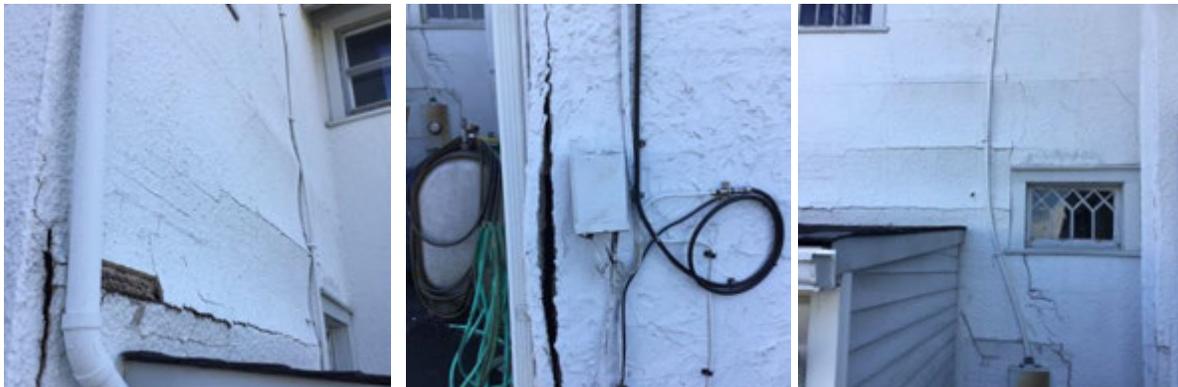
**17-04-11**

Hazard – Exterior. Concrete type material is loose and has fallen off the building in the past. Make arrangement to repair the building. Do not allow access to any areas known to be in the fall zone.

*Images of exterior deteriorating*

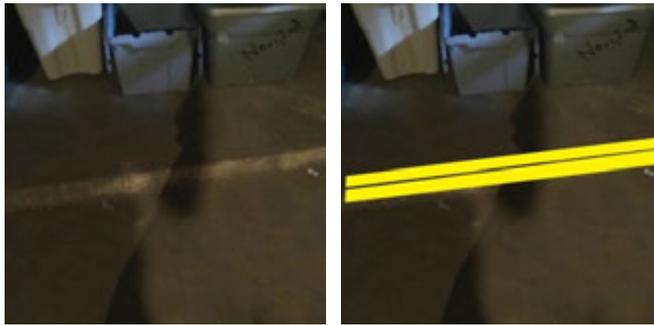
**17-04-12**

Slip/Trip/Falls – Raised Floor. The concrete floor is raised in multiple areas. Use a contrasting color to mark the edge of each step. Elevated concrete platforms and steps should be marked to minimize tripping potential.

*Images of uneven concrete*

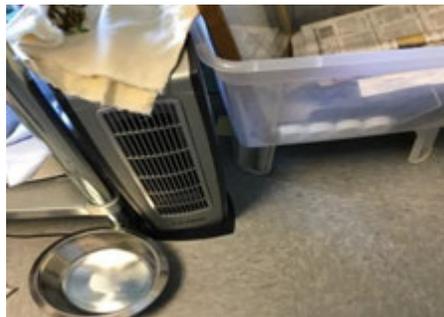
17-04-13

Fire – Space Heaters. Space heaters should be discouraged except in the most extreme situations. Ideally temperature control issues would be addressed in a more permanent manner. In the rare cases where space heaters are needed criteria should be followed to minimize the risk. Attached to this report is an in-depth description of fan and space heater usage. The highlights are listed below:

*Image of space heater*

- Maintain clearance according to the manufacturer’s instructions (normally 3 ft) and do not place other combustibles on the heater when in use.
- Do not leave unattended (turn it off when leaving the room - unplugged at end of day)
- Plug directly into wall outlet (no extension cords or power strips)
- Use approved by supervisor.

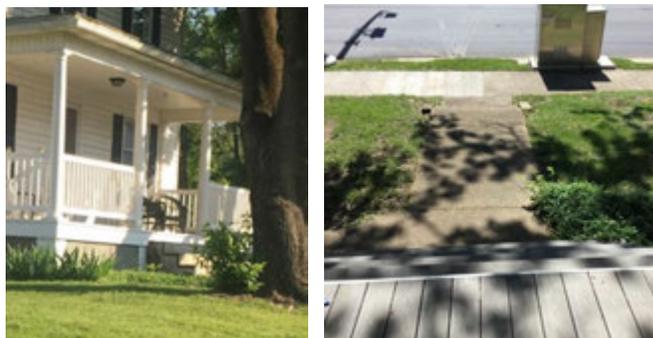
17-04-14

Slip/Trip/Fall – Rail. The residence porch steps do not have a rail. Even though the steps and porch are not intended to be used, it is possible for someone unfamiliar with the property to try to access the home this way. Install a rail on the steps or use a gate, rope or chain with a sign to direct all visitors to the parish office, “No Access. All visitors please check in at the parish office.”

*Images of missing railing*

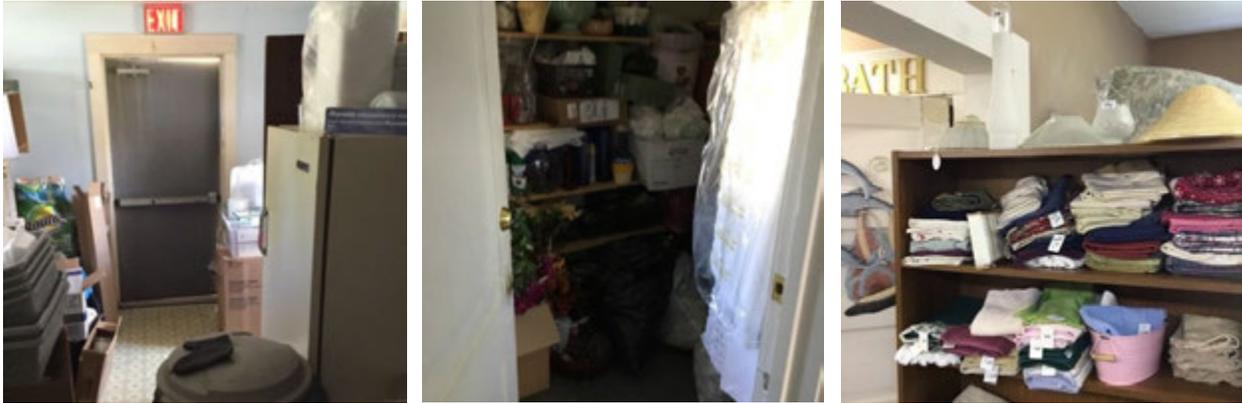
17-04-15

Hazard – Storage. Storage areas present many hazards if not maintained in a proper manner. Potential for lifting, bending and twisting injury increases as the pile height and width increases. Proper aisles, sturdy shelving and piles maintained at a manageable size will reduce the potential for injury. Periodically organize the storage areas and purge extra supplies, decorations, and materials. Evaluate and secure all shelving.

*Image of storage areas and unstable shelves*

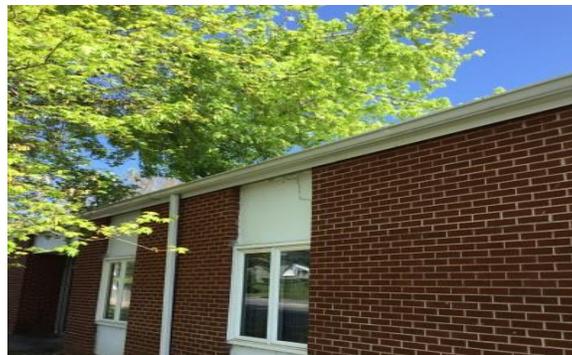
17-04-16

Maintenance – Exterior. Trees and shrubs touching or overhanging the buildings create several issues. The leaves and branches often reduce the drainage from the roof and gutters causing water damage. It also creates easy access points for insects and rodents. Trim trees and bushes away from the buildings.

*Image of overreaching tree*

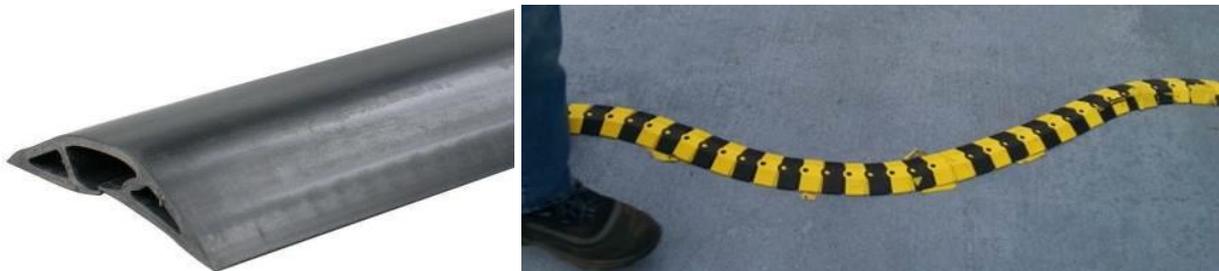
Slip/Trip/Fall – Cord Protection. Slips, trips and falls can be minimized by having available and using the correct equipment. Provide easily accessible step stools. Encourage volunteers and staff to minimize the use of extension cords and to also consider trip protection when using them. Many varieties of cord protectors are available that both protect the cord from deterioration and reduce the trip potential. Below are pictures of just a couple.

*Images of cord protection*
